HEAT STERILIZED NICKEL-CADMIUM CELL  
FAILURE ANALYSIS PROGRAM

Phase II  
Final Report

JPL Contract No. 951092

TRW Systems  
One Space Park  
Redondo Beach, California

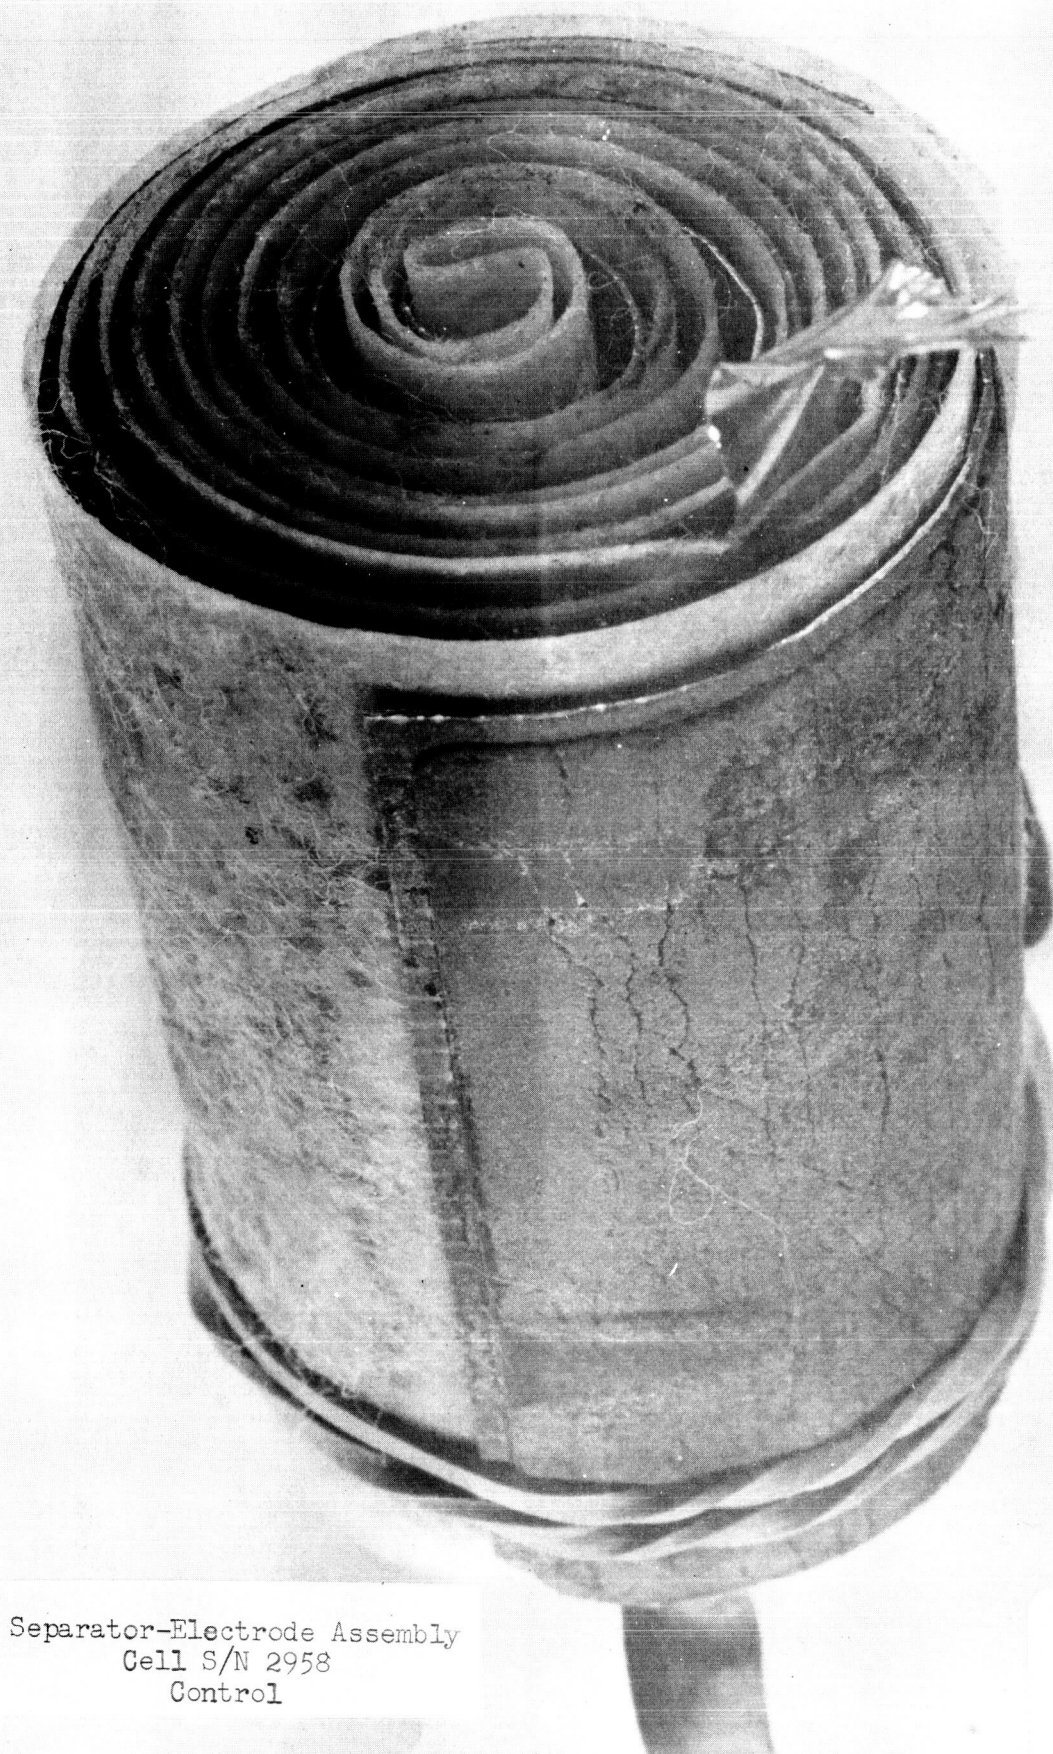
Figure 2

Figures 2, 4, 6, and 8 show photographs of the separator-electrode assemblies as they were when removed from the case for cells S/N 2958 (control), 2985 (no sterilization, float 230 days, life cycled), 2986 (sterilized, float 230 days, life cycled) and 3028 (sterilized at 100% charge, life cycled) respectively. Note the adherence of fibrous separator material to the electrodes for those cells float charged for 230 days, then life cycled for both the sterilized and non-sterilized cells (Figures 4 and 6). This was noted on all cells except the control cell (Figure 2) in which there was no adhering separator material, and the cells which were sterilized in the partially or fully charged state (Figure 8) where the separator was partially destroyed.

Separator-Electrode Assembly  
Cell S/N 2958  
Control

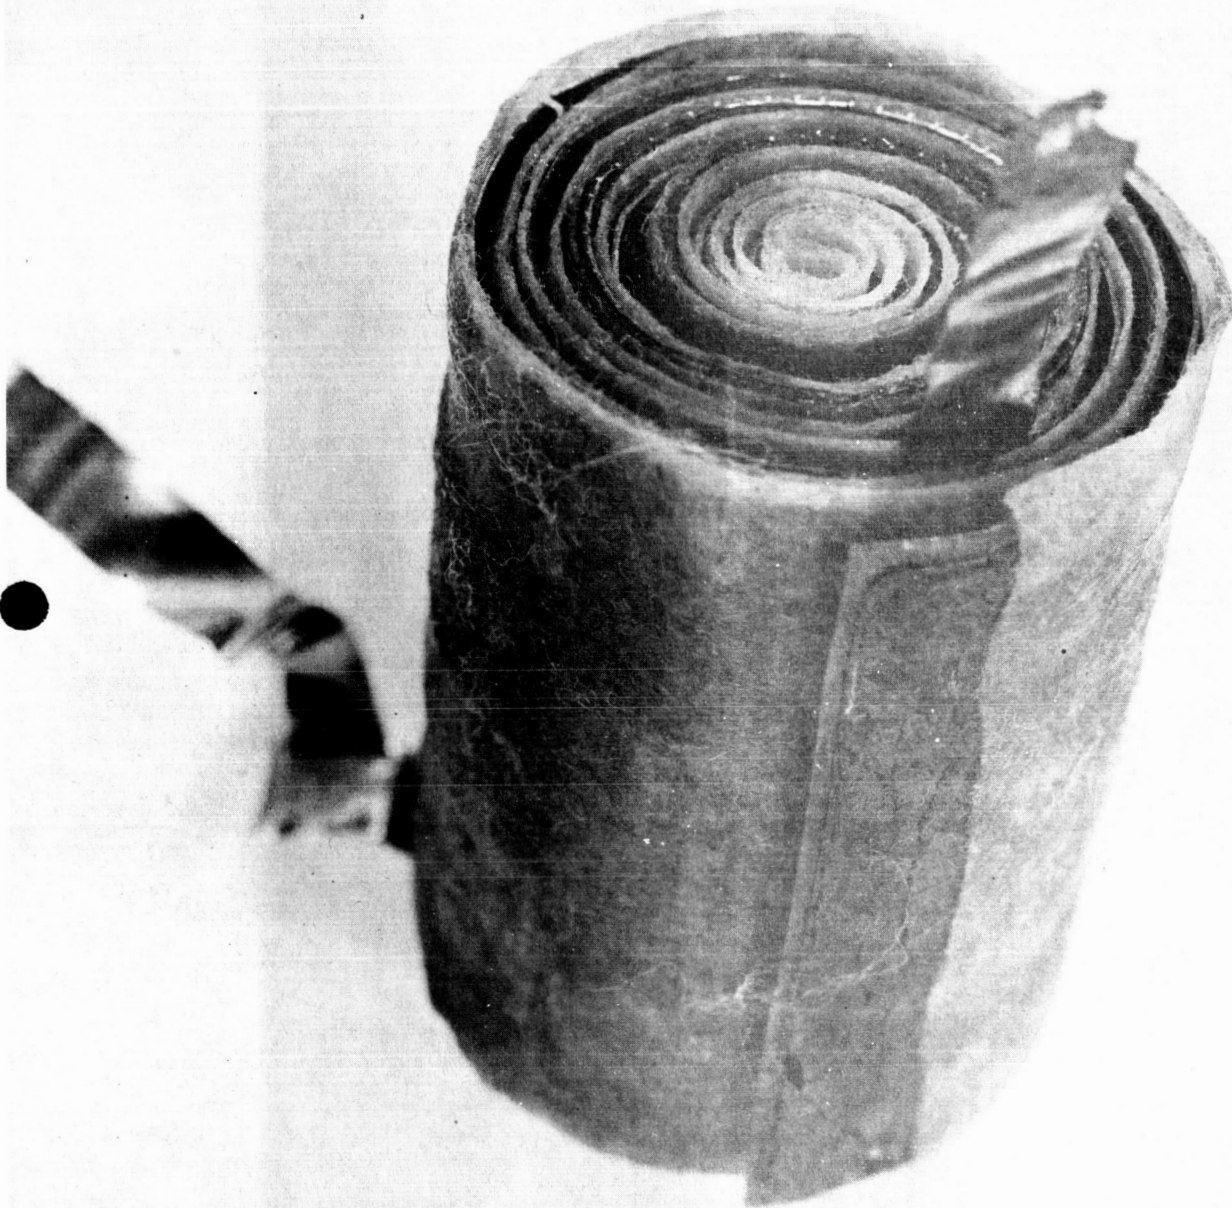
Figure 6

Separator Electrode Assembly  
S/N 2986  
Sterilized, Float 230 Days, Life Cycled

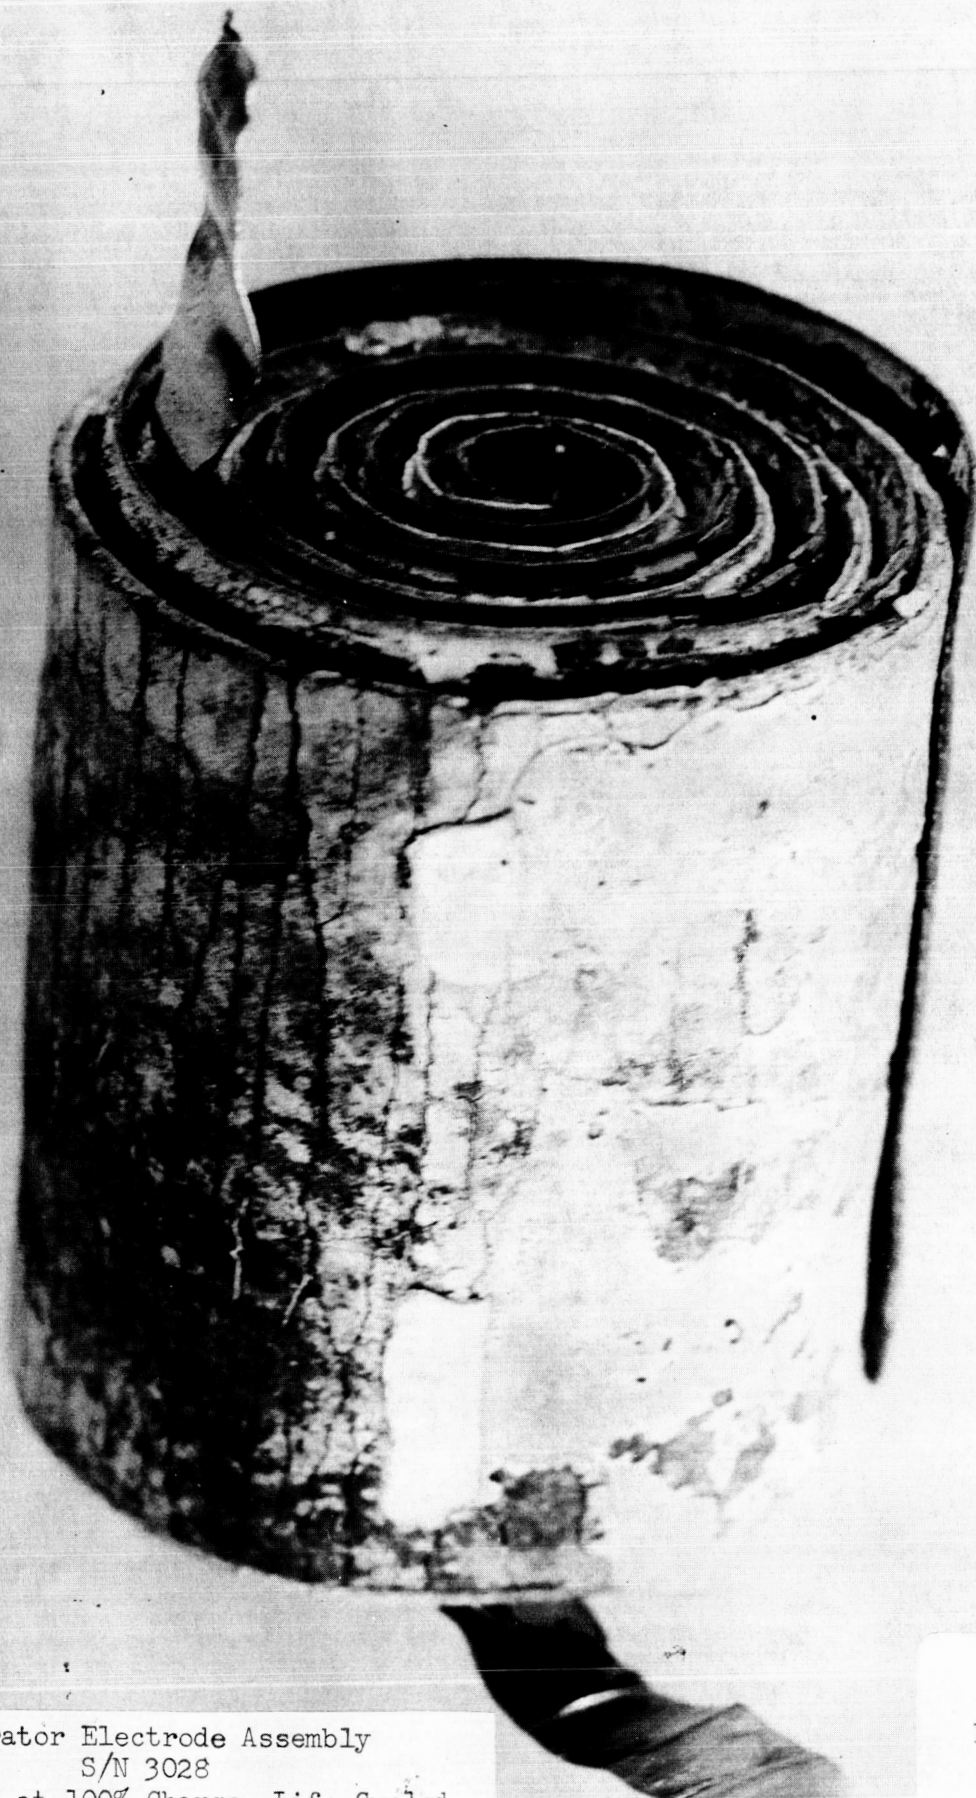
Figure 8

The separator in the cells which were sterilized at 70% and 100% charge were severely degraded. The separator from the 70% charged cell had some degree of continuity but that from the 100% charged cell was discontinuous. The separator material in these cells was very brittle and flaky. The separator in the 30% charged cell was continuous but showed evidence of degradation in that it was warped and more brittle than the separator in the control cell.

Separator Electrode Assembly  
S/N 3028  
Sterilized at 100% Charge, Life Cycled
